XV Tuner Bad Flashed custom file fix

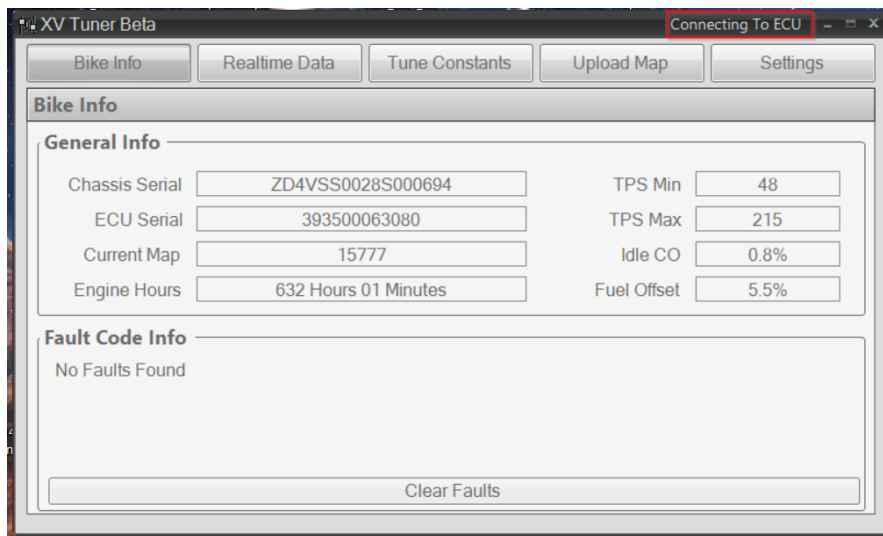
Here Bike Info data is loaded correctly, even offsets/TPS settings are loaded but the status still says “Connecting to ECU”

To fix this please upload a known good map (best use stock maps, here im using latest Dual Mapping for Full Power)

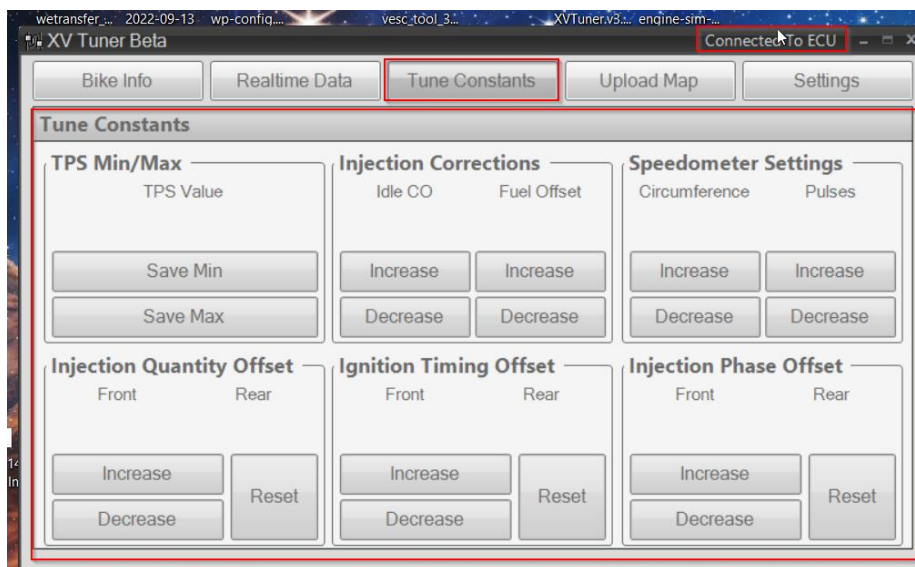
Here on Tune Constants Tab we get no data, pressing buttons does nothing or throws error. Connection Status still says “Connecting To ECU”

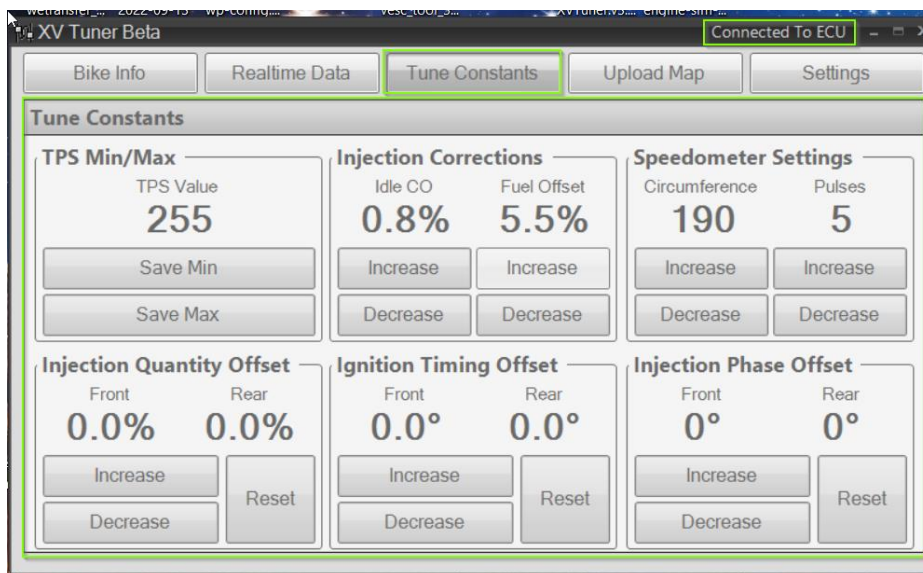
After flashing a good file, this is how a normal behaviour should look like
